CONNECTICUT
DEPARTMENT
OF
TRANSPORTATION

CONDITION INSPECTION
BRANCHVILLE STATION

**CONN. DEPT OF TRANSPORTATION
STATION INSPECTION**

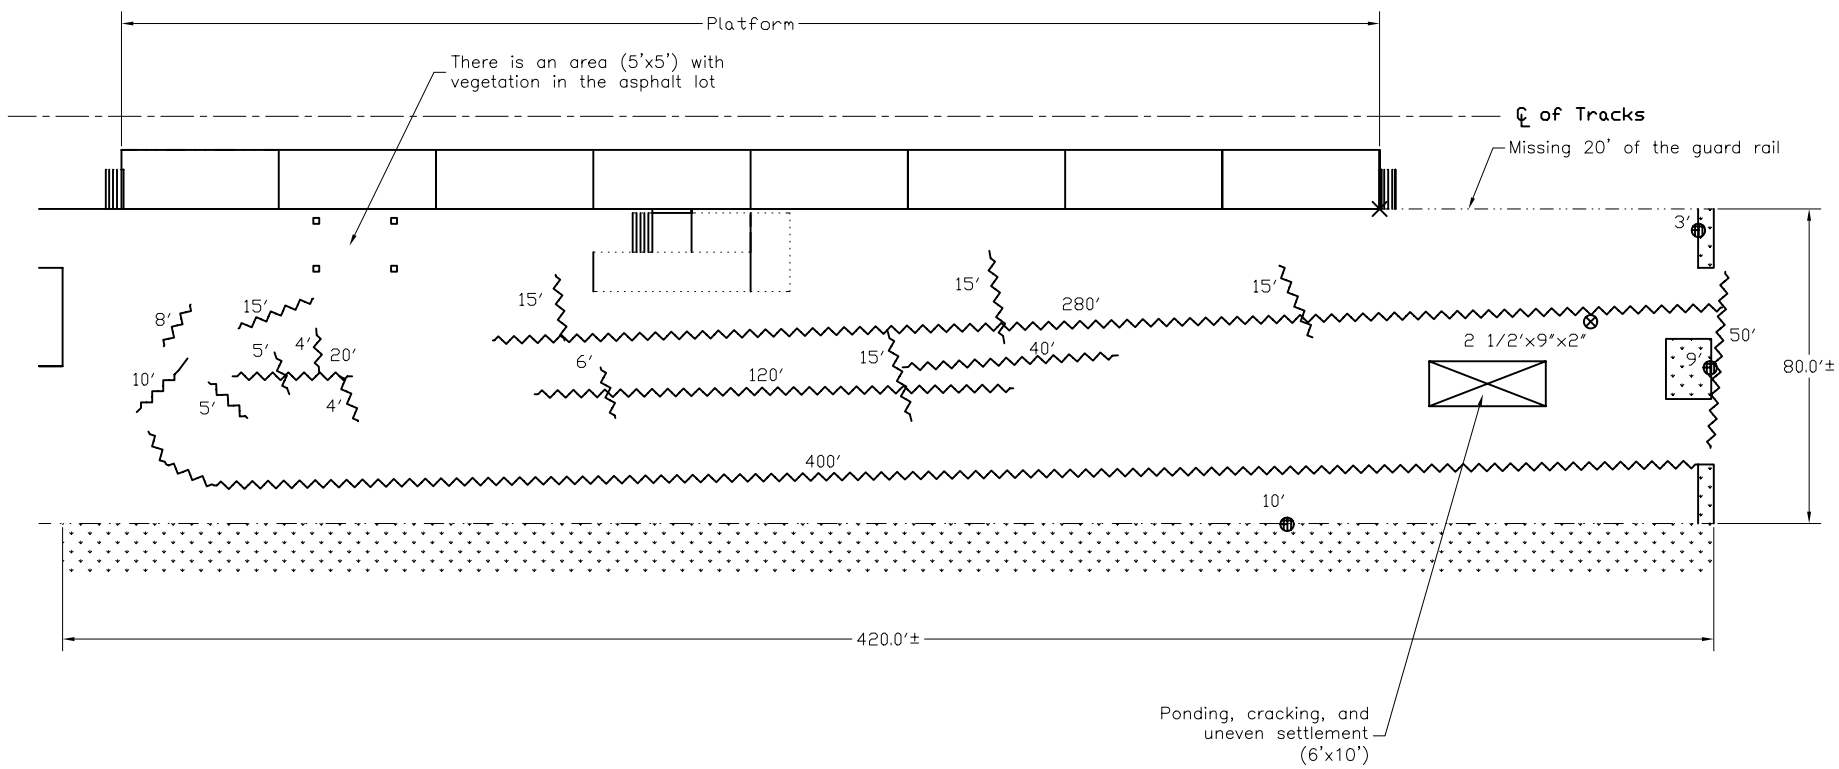
Urbitran Associates, Inc.
Connecticut Dept. of Transportation
Branchville Station Quadrant I Plan
Date: 12-5-01

CONDITION OF PAVED SURFACE: 2

CONDITION OF STRIPING: 2

FENCE AND GUARDRAIL: 1

CURB: 2

- Legend:
- Guard Railing
 - Pedestrian Railing
 - ~~~~~ Cracks
 - ▭ Grass
 - Sanitary Manhole
 - Ⓟ Ponding
 - ⊗ Pothole
 - Ⓢ Missing or Spalled Curb
 - ▣ Bollards

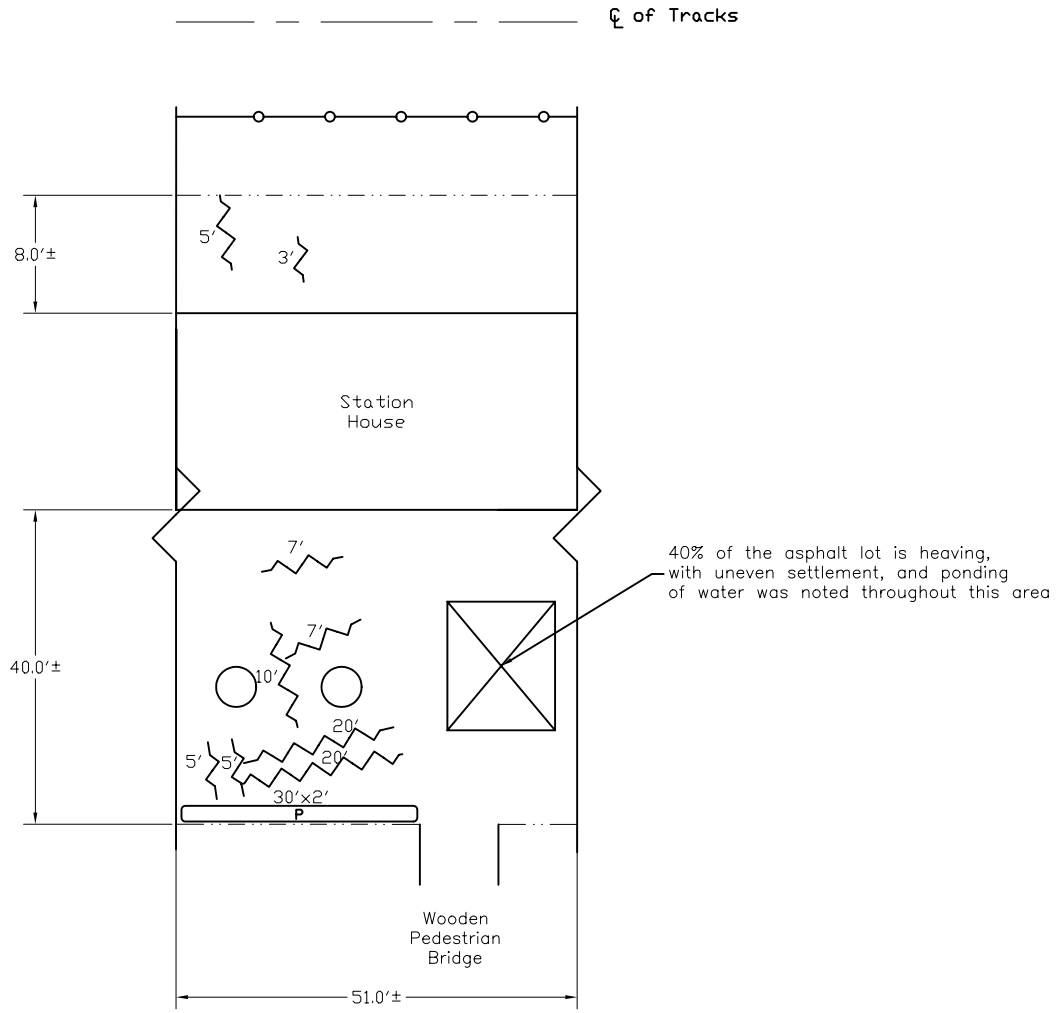
Urbitran Associates, Inc.
Connecticut Dept. of Transportation
Branchville Station Quadrant II Plan
Date: 12-5-01

CONDITION OF PAVED SURFACE: 1

CONDITION OF STRIPING: 1

- Legend:
- Fence
 - - - - - Guard Railing
 - ~~~~~ Cracks
 - Sanitary Manhole
 - Ⓟ Ponding

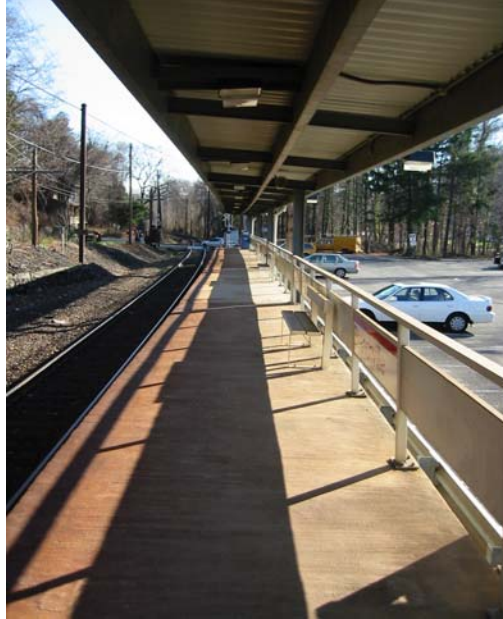
Description: _____
General view of the platform

Reference: _____
Looking south

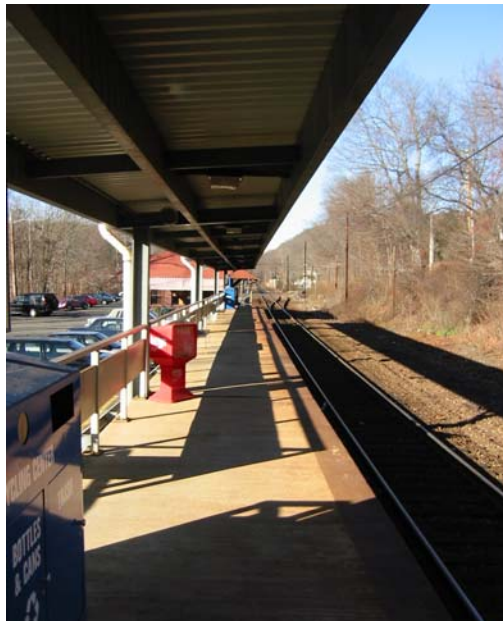
PHOTO NO. 8

Location: _____
Middle of Span III

Description: _____
General view of the platform

Reference: _____
Looking north

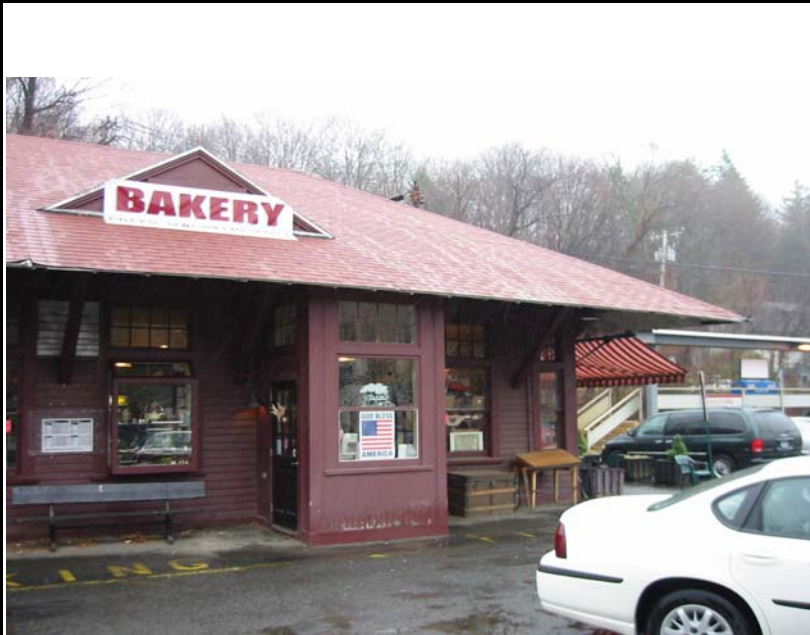
Description: General view of the west exterior face of the station house

Reference: Looking Southeast

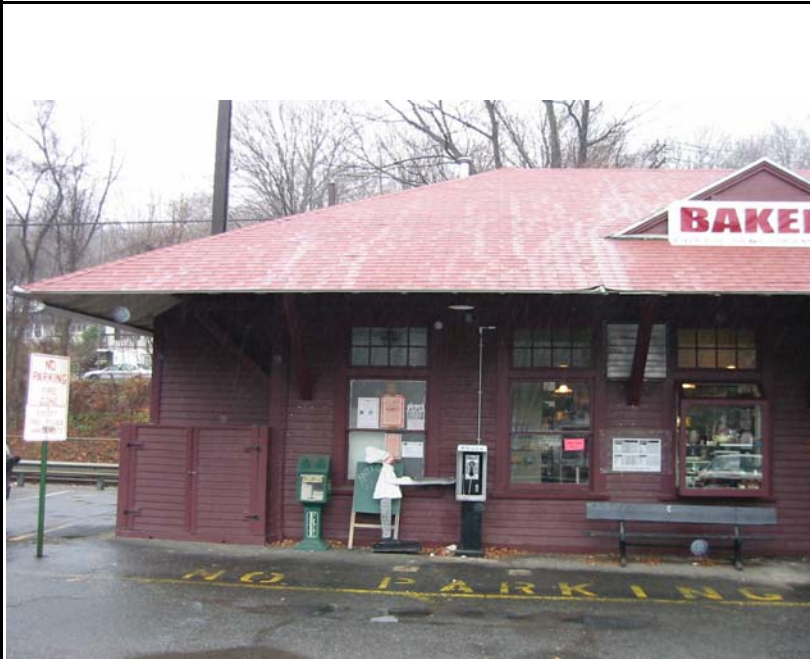
PHOTO NO. 10

Location: Westside of Quad II

Description: General view of the west exterior face of the station house

Reference: Looking Northeast

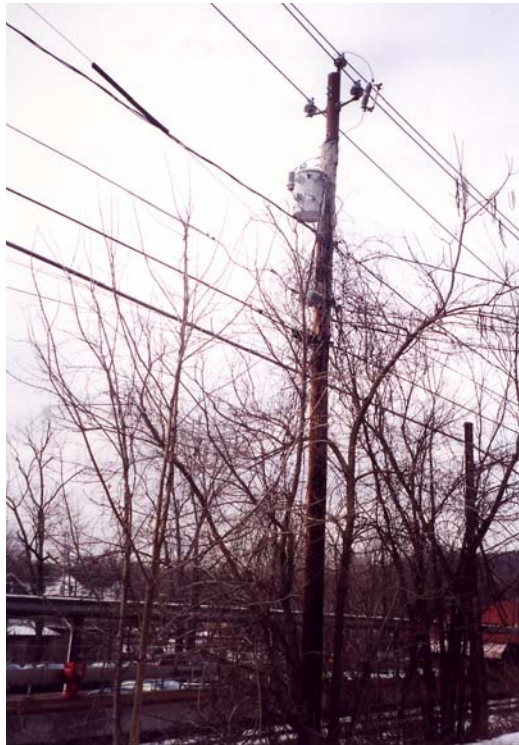
The building service originates from an electrical utility pole located across the railroad tracks on Peachable Street. The main panel is located in the kitchen and a sub panel is located in the dining area. Both panels have minor deterioration, but are functioning as originally designed.

Description:
building electrical
service pole

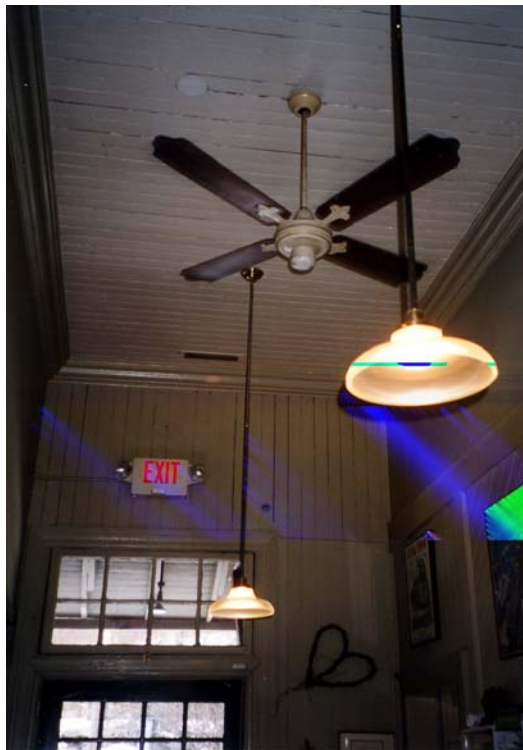
PHOTO NO. 31

The building lighting was not measured because of the limited access to the bakery during hours of darkness. However, calculations of the entrance area were performed and estimated the lighting to be 10 foot-candles. Egress and exit lighting are present at the main doors but the rear door does not have any. We recommend that an exit sign and additional egress lighting be installed to meet the Life Safety Code.

Location:
building entrance

Description:
building lighting

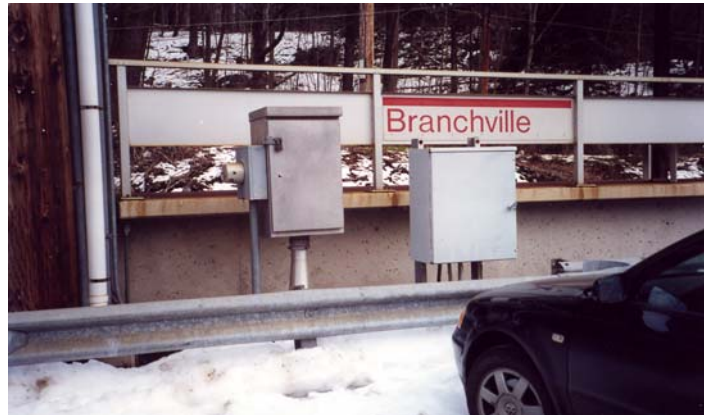
PHOTO NO. 33

Remarks: The receptacles are not GFCI and mostly broken.

Location:
parking area

Description:
platform electrical
service pedestal

The platform power originates at the building with a couple of circuits for the platform receptacles and platform lighting. The few non-GFCI receptacles are missing their covers and exposing people to possible electric shock. We suggest that the receptacles be replaced with GFCI type with covers.

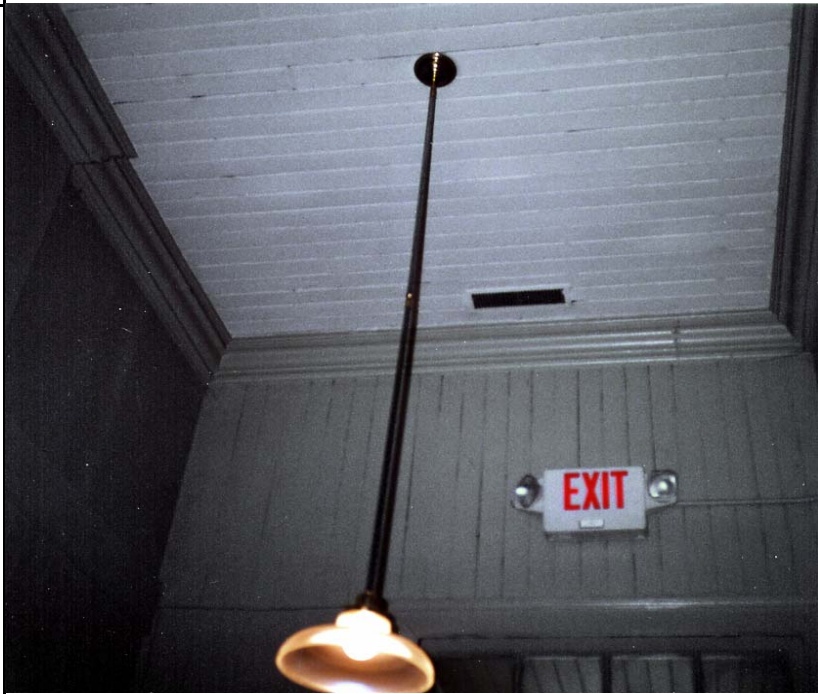
PHOTO NO. 37

Ceiling fan working, air supply grille in the ceiling, 1 supply grille in kitchen, 1 return in kitchen. Good Repair

Description:
Ceiling
Grille
Air Supply

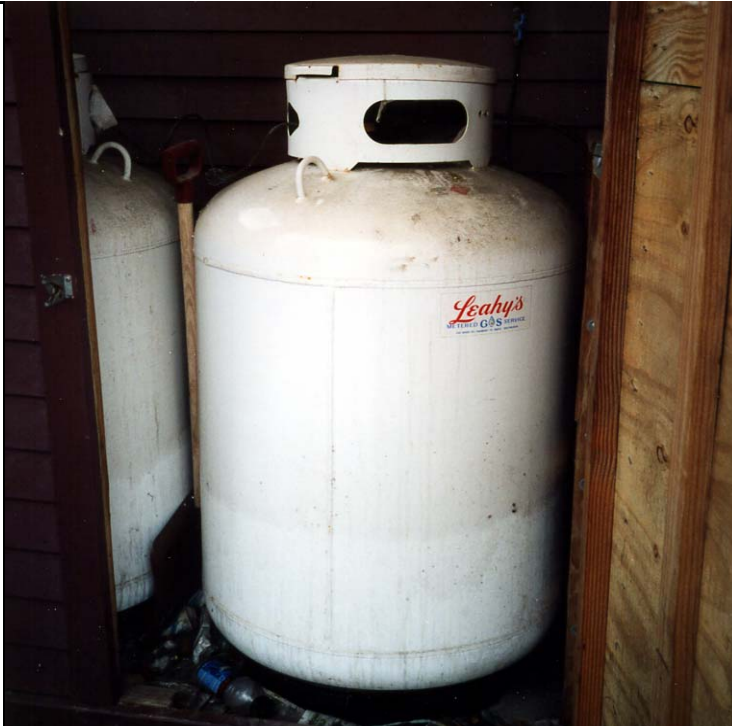
LPG stored in two outdoor cylinders with pressure regulator. Good Repair

Description:
Outdoor
LPG
Cylinder
